Environment Protection Authority

Preliminary Methane Investigation Landfill Screening Project

January 2009

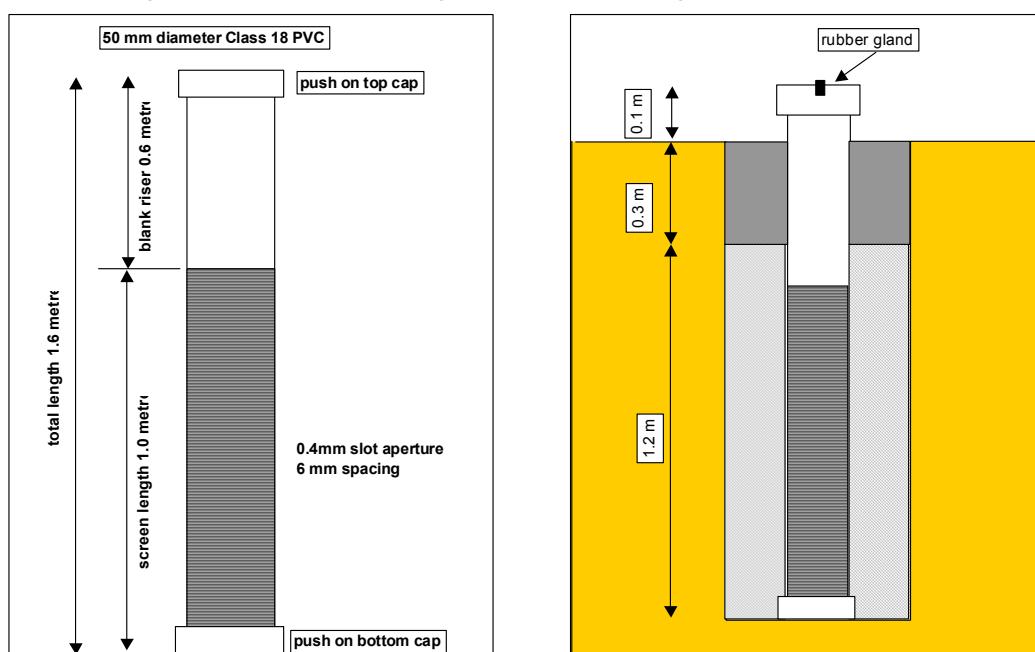
Figure 2.1 - Landfill Gas Monitoring Probes - Schematic Design

Bore construction was as indicated in Figure 2.1, except where auger refusal caused bores to be established to depths less than 1.5 m below ground level. Where shorter bores were established, the excess section of pipe was cut from the slotted or bottom part of the bore. The shortest bores established were 0.8 to 0.9 m below ground level.

Installation Method:

1. Hand auger down to 100 mm for initial u/g service check EVEN IF dial-before-you-dig indicates no services in area.
2. Ream out hole using motorised auger and continue (if possible) to total depth of 1.5 m
3. IF BOREHOLE IS UNSTABLE, use PVC sleeving to keep hole open ie alternate between augering and rotating the sleeve in - TURN AUGER OFF before using the sleeve
4. Place top cap on pipe
5. Backfill with 1840 graded sand (or equivalent) back up to 0.2 m above top of slotted section
IF using PVC sleeve, alternate between pouring sand in and pulling sleeve out (using vice grips or other similar device)
6. Check on sand level with steel measuring tape - once at 0.3 m below ground, stop
7. Pour in bentonite up to 5 cm below ground level, and hydrate with 500 mL of water
8. Drill hole into top of top cap, and place rubber gland in hole

As indicated in Figure 2.1, the holes in the ground were established using a hand auger and/or a motorised auger. In a couple of instances, due to the presence of rock, larger drill rigs were provided and used by specialist sub-contractors in order to establish the bores.

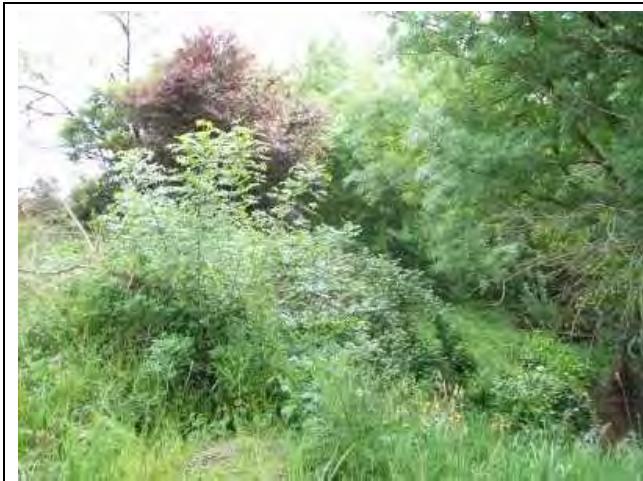
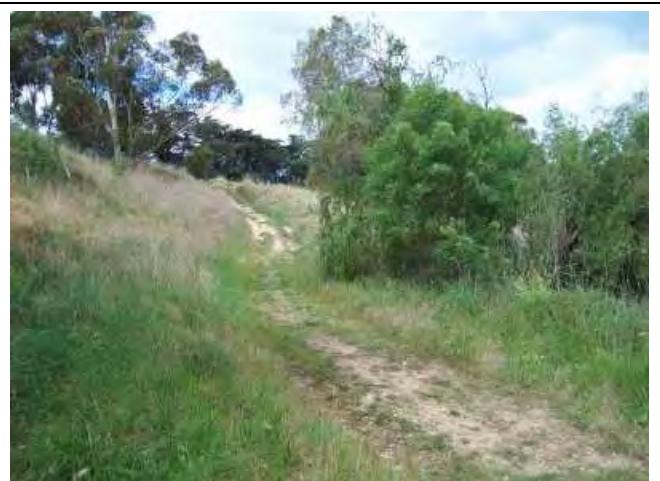
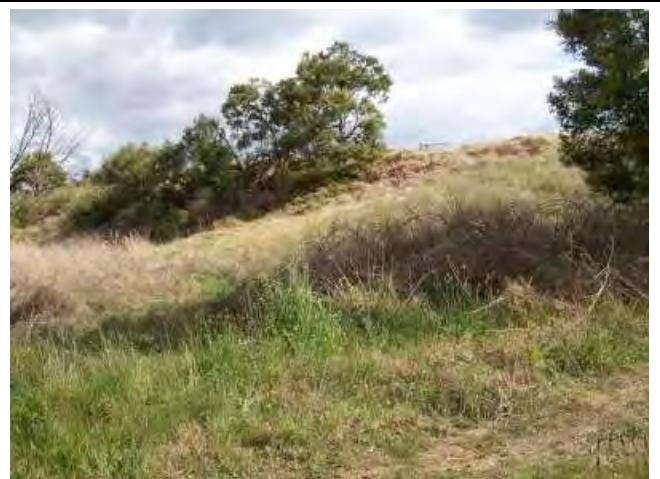
Bairnsdale (LS 169)

High methane levels recorded at this bore were suspected to be caused by the large amounts of organic material in the soil surrounding. A sample was taken and monitored, however, the results were inconclusive. Further monitoring or investigation is recommended to better determine the source of the methane.

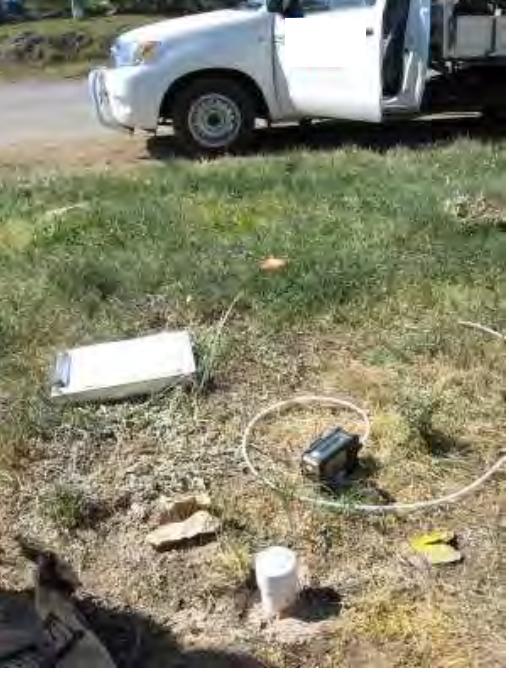
A photograph showing the bore setup for B12 - North. A white pickup truck is parked on the left. In the center, there is a white rectangular container, a black cylindrical probe connected by a cable, a white cup, and some stones. The ground is grassy and uneven.

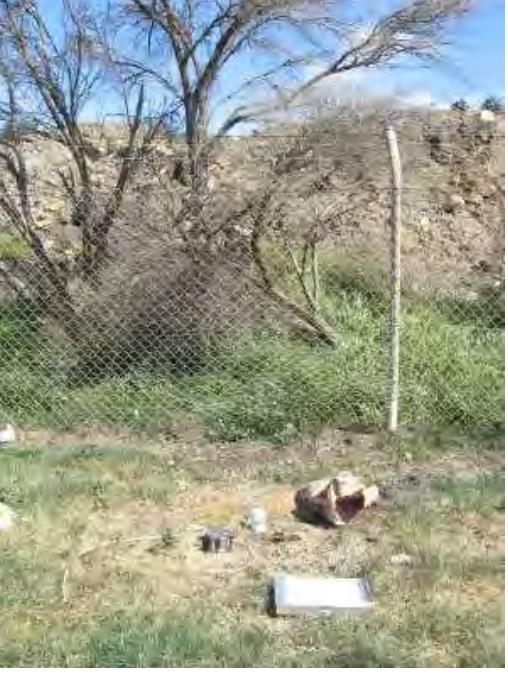
A photograph showing the bore setup for B12 - South. It features a chain-link fence in the background. In the foreground, there is a white rectangular container, a black cylindrical probe, a white cup, and some stones on a grassy area.
B12 – North	B12 – South

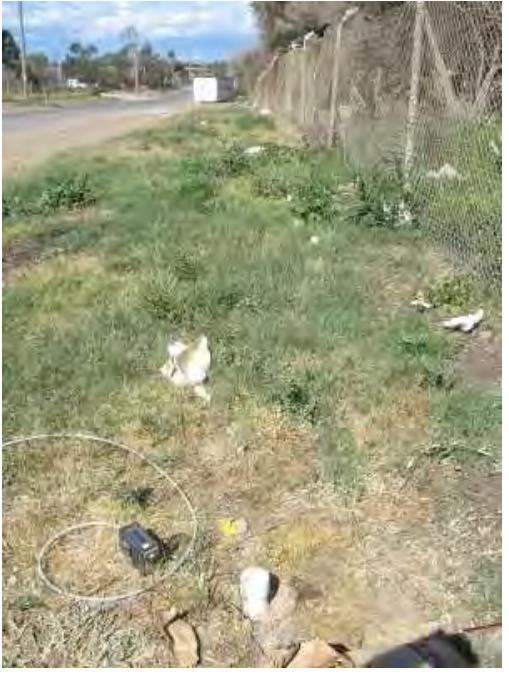
A photograph showing the bore setup for B12 - East. It is similar to the North setup, featuring a white rectangular container, a black cylindrical probe, a white cup, and some stones on a grassy area.

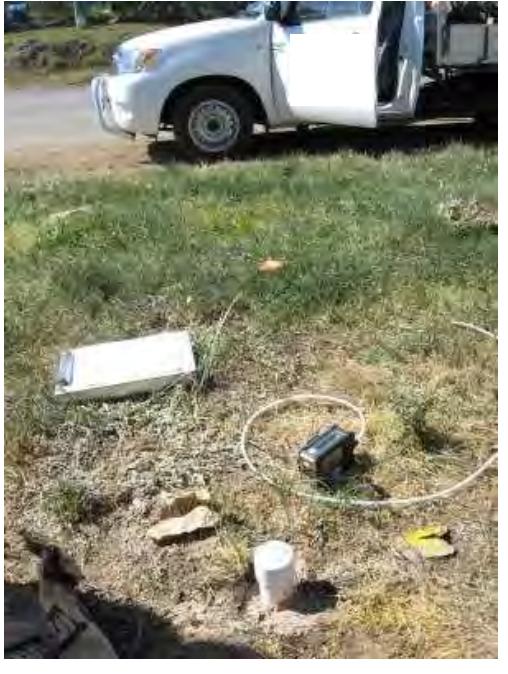
A photograph showing the bore setup for B12 - West. It is similar to the North setup, featuring a white rectangular container, a black cylindrical probe, a white cup, and some stones on a grassy area.

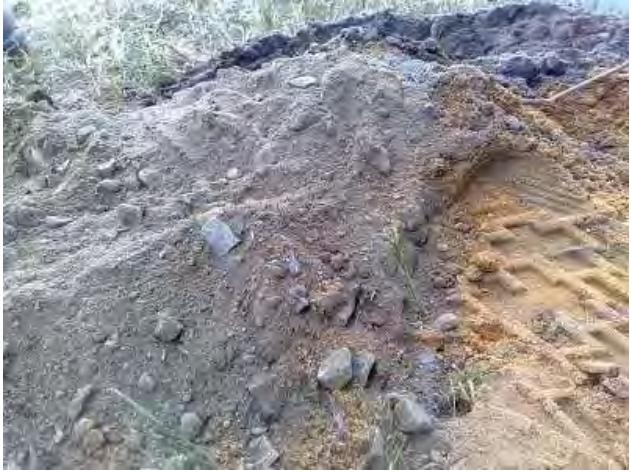
A photograph showing a vertical soil profile. The top layer is dark, possibly organic material or compost. Below it is a lighter-colored, more weathered soil layer. A distinct yellowish-brown stain or leachate plume is visible in the lower part of the profile, indicating environmental contamination.

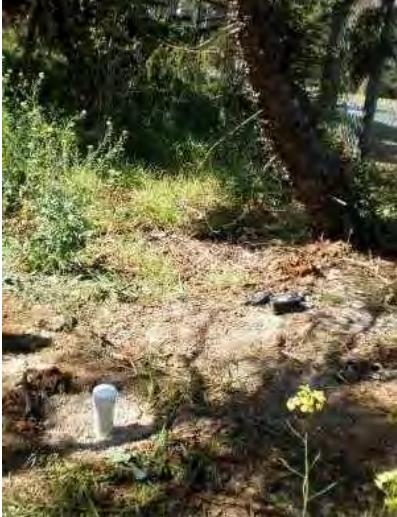
A photograph showing a white cylindrical soil sample tube standing upright in a patch of dry, brownish ground. The background is filled with dense green bushes and trees.

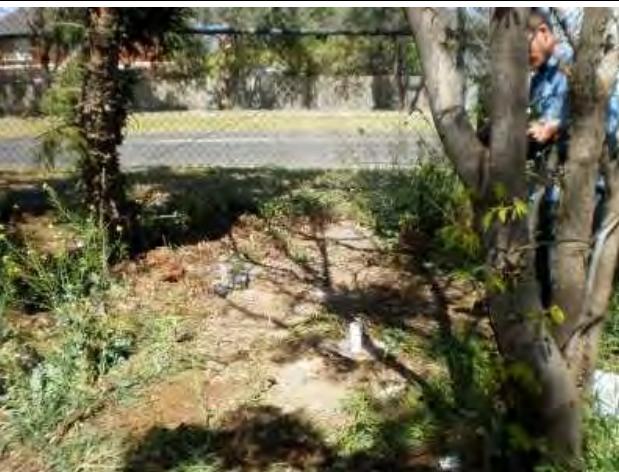
A photograph of a white cylindrical soil sample tube standing in a dry, brownish area next to a large tree trunk. In the background, there's a chain-link fence and some buildings across a road.	B5 – South

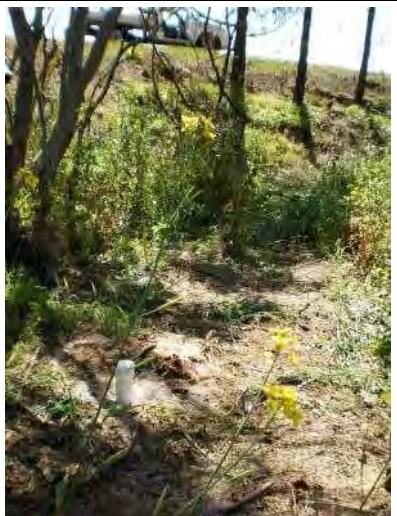
A photograph of a white cylindrical soil sample tube standing in a dry, brownish area with sparse vegetation and a few small yellow flowers. A chain-link fence runs across the background.
B5 – East	B5 – West

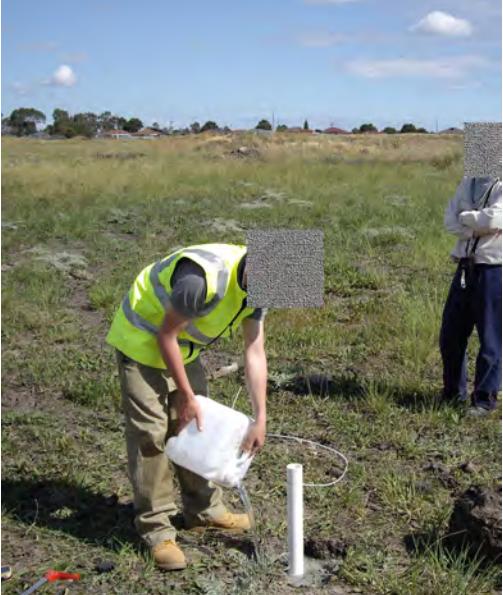
A worker in a yellow high-visibility vest and brown pants is kneeling on a grassy field, pouring liquid from a white bucket into another white bucket. A vertical white pipe is standing upright in the ground nearby. Another person is standing in the background. The sky is blue with some clouds.

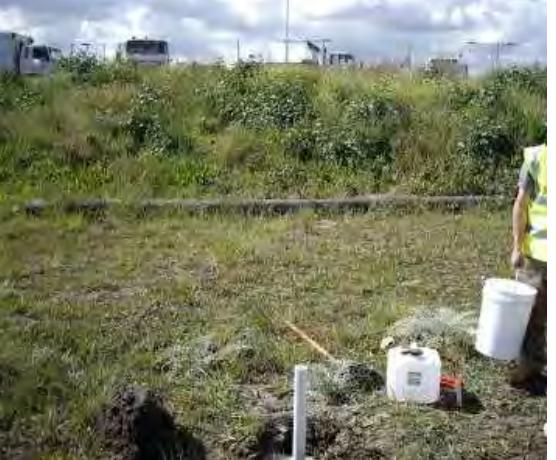
A worker in a yellow high-visibility vest and brown pants is kneeling on a grassy field, pouring liquid from a white bucket into another white bucket. A vertical white pipe is standing upright in the ground nearby. A white drum and some tools are visible on the ground. In the background, there is a grassy embankment and a road with vehicles. The sky is blue with some clouds.
B2 – North

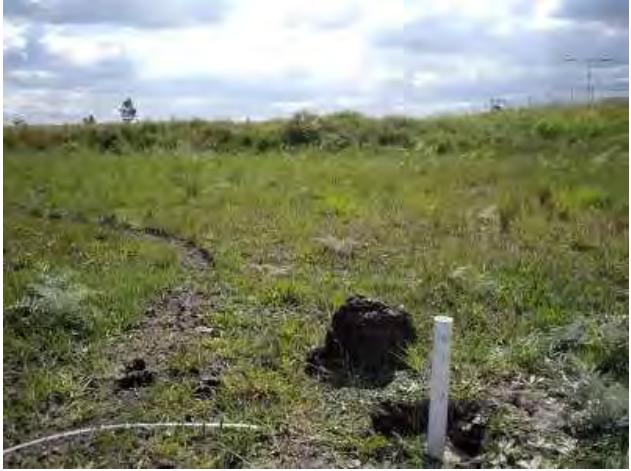
A view of a grassy field showing a vertical white pipe standing upright in the ground. The sky is blue with some clouds.	B2 – South

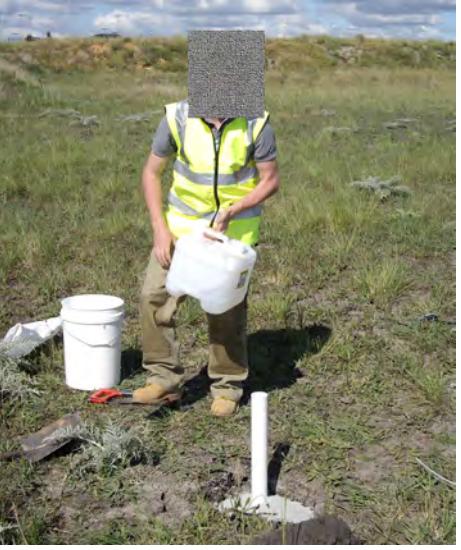
A worker in a yellow high-visibility vest and brown pants is kneeling on a grassy field, pouring liquid from a white bucket into another white bucket. A vertical white pipe is standing upright in the ground nearby. A white drum and some tools are visible on the ground. The sky is blue with some clouds.
