Derrimut chemical fire: environmental sampling and findings

Science report

September 2024

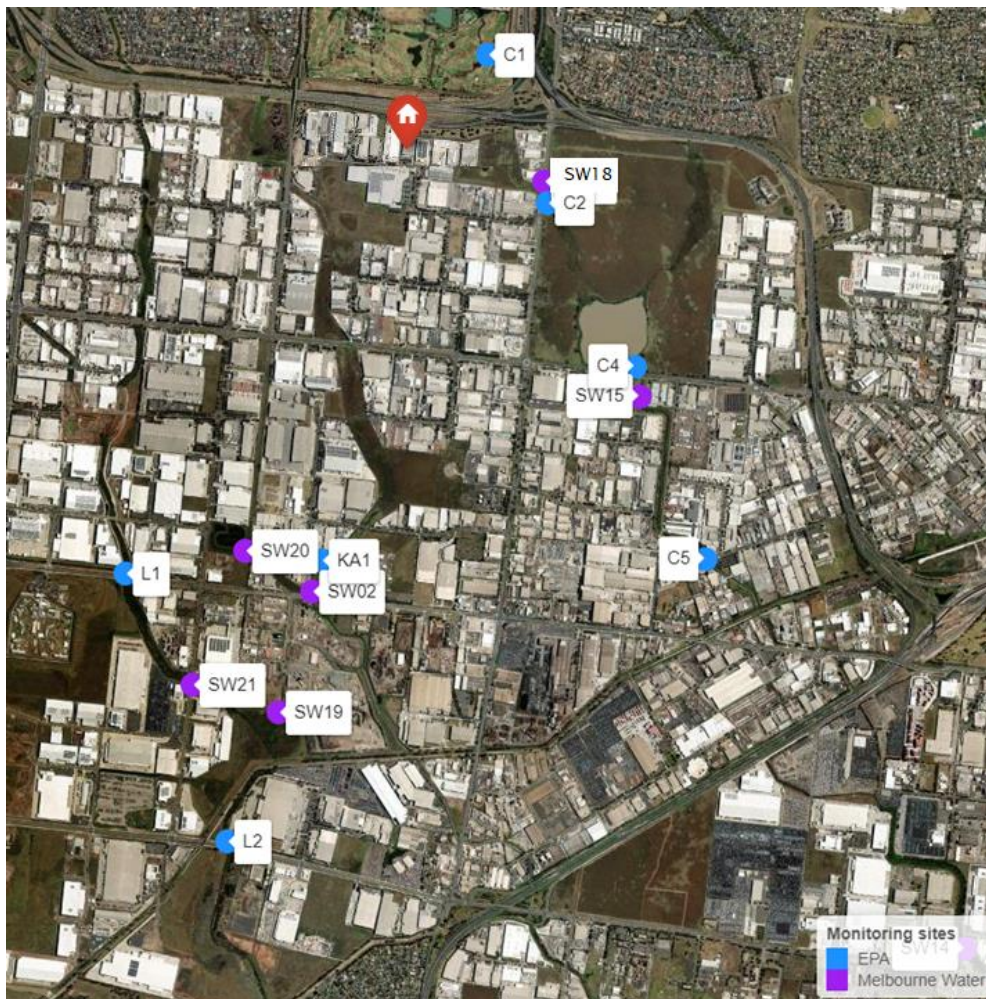
Figure 3. Location of EPA and Melbourne Water monitoring sites along the Kayes Drain, Laverton Creek and Cherry Creek waterways. Refer to Appendix A1 for list of sites and map codes. Red pin shows location of fire.

In the days following the fire, EPA and Melbourne Water monitored firewater-affected waterways to assess risks to the aquatic environment and human health (Figures 3 and 4).

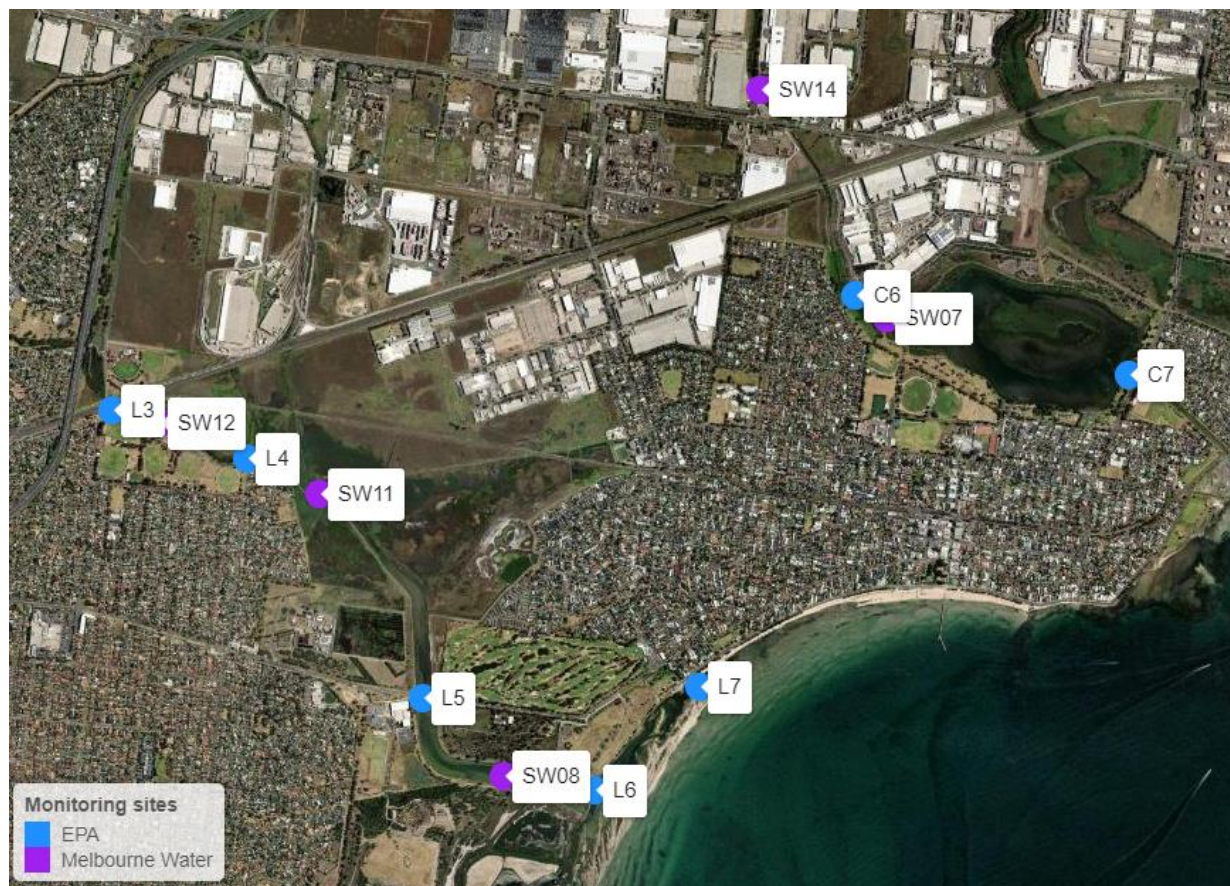
Figure 4. Location of downstream EPA and Melbourne Water monitoring sites on Laverton Creek (left) and Cherry Creek (right).

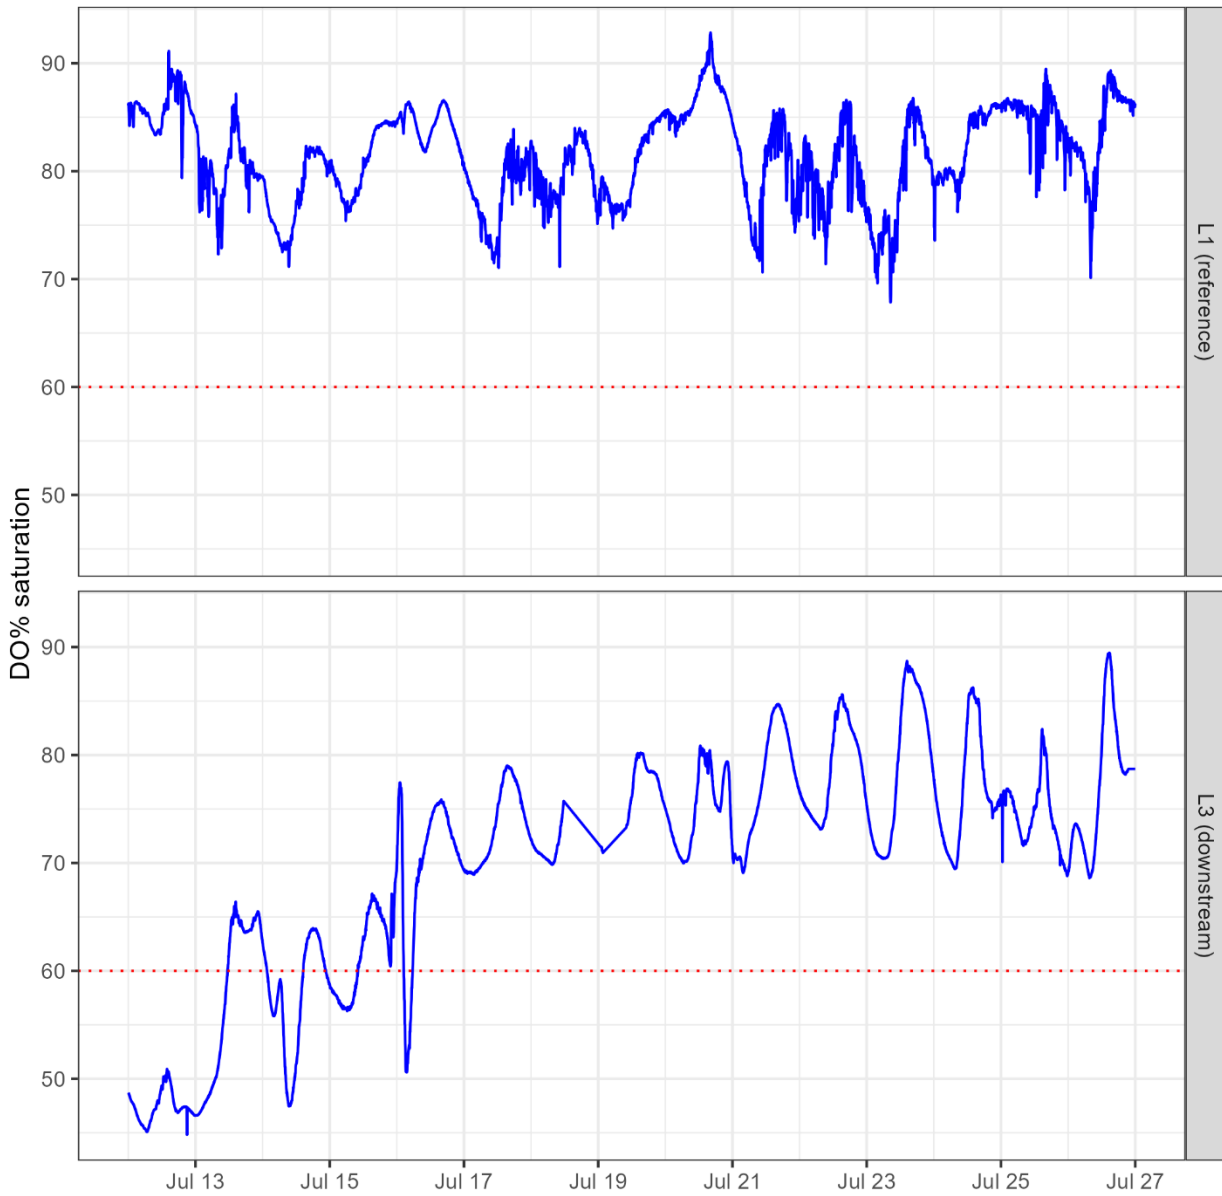
Figure 6. Dissolved oxygen (DO%) levels in Laverton Creek shown recorded by Multiparameter Water Quality loggers deployed upstream at site L1 (reference site) and downstream at L3 between 11-26 July 2024

Dashed line at 60% represents Environmental Reference Standard (ERS) for dissolved oxygen.

Figure 7 displays dissolved oxygen levels in Laverton Creek upstream of the Kayes Drain intersection at Dohertys Road (L1), and downstream at Merton Street (L3). Dissolved oxygen levels on 12 July 2024 were below 50% saturation at Merton Street (L3), below the ERS level of 60% for this waterway.

Lower dissolved oxygen levels at Merton Street (L3) were associated with a high chemical oxygen demand in water samples (530 mg/L compared to background 45 mg/L) and the presence of a range of firewater chemicals. Over the next 5 to 7 days, these returned to levels similar to the reference site at Dohertys Road (L1), between 70 to 90% dissolved oxygen saturation.

Dissolved oxygen at Merton Street (L3) had returned to levels above 60% saturation by 16 July 2024, and remained at this level until 27 July 2024 when monitoring ceased.

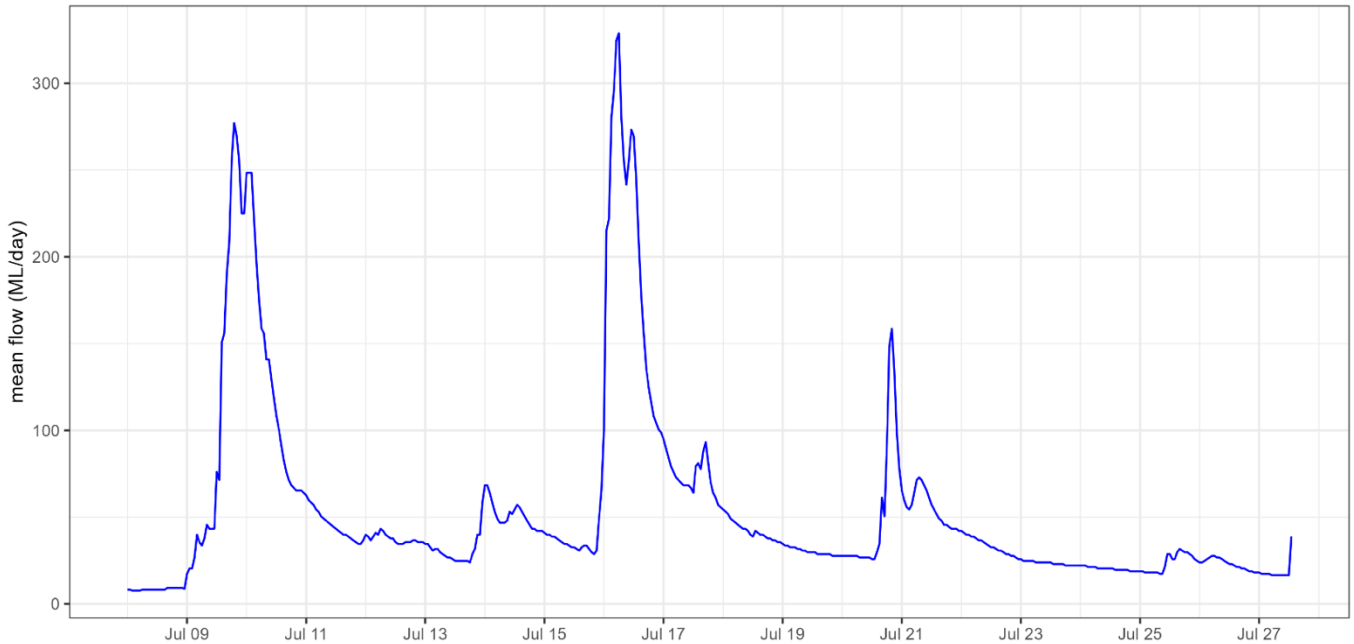
Figure 7. Kororoit Creek mean daily flows (ML/day) at Federation Trail, Brooklyn.

Follow-up sampling on 17 and 18 July 2024 found that all these chemicals had declined to levels below the laboratory detection limit, indicating significantly lower risk to aquatic ecosystems in Kayes Drain. These declines are attributed to the high volatility of these chemicals (due to loss via evaporation), as well as dilution and flushing by higher stream flows on 17 July 2024 (see Figure 7).

Local creeks were flushed by rainfall-driven higher flow events on 16 and 20 July 2024 (**Error! Reference source not found.7**). The Bureau of Meteorology weather station at Laverton recorded 13.4 mm of rain on 16 July. The rainfall runoff diluted firewater contaminants, reducing their overall concentrations on 18 July, and aiding in flushing contaminants from affected areas.

No daily flow measurements are available for Laverton or Cherry Creeks due to the absence of flow gauges on these creeks. Therefore, flow data from adjacent Kororoit Creek was used to represent local flow conditions in the area. Kororoit Creek, Laverton Creek and Cherry Creek share physical similarities.
